# **INDOOR AIR QUALITY ASSESSMENT**

**Atkinson Elementary School  
111 Phillips Brooks Road  
North Andover, Massachusetts**

Prepared by:  
Massachusetts Department of Public Health  
Bureau of Environmental Health Assessment  
October 2002

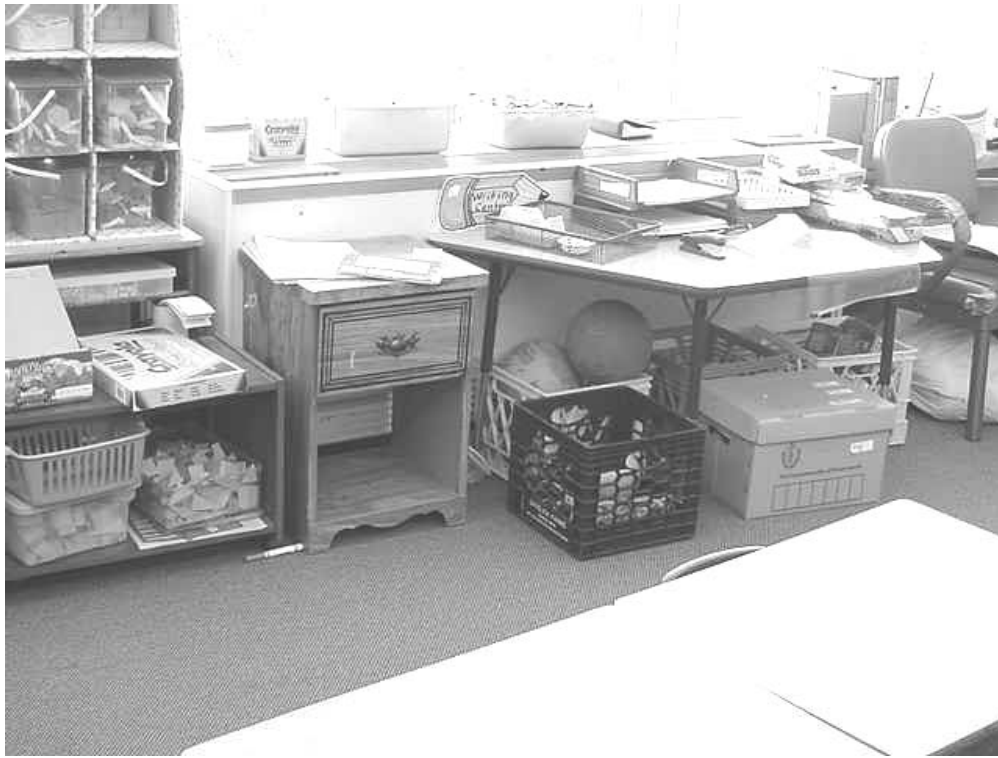
**Picture 1**

Fresh air in classrooms is supplied by a unit ventilator (univent) system. Univents draw air from outdoors through a fresh air intake located on the exterior walls of the building and return air through an air intake located at the base of each unit ([see Figure 1](#)). Fresh and return air are mixed, filtered, heated and provided to classrooms through a fresh air diffuser located in the top of the unit. Univents were found deactivated in many areas. Univents in this wing do not run continuously but are activated by thermostats once room temperatures drop below a set level. When the room temperature exceeds the thermostat setting, univents deactivate. Without mechanical ventilation running continuously, fresh air cannot be introduced into classrooms on a consistent basis. Obstructions to airflow, such as paper and boxes stored on univent air diffusers and items in front of univent return vents, were also noted in classrooms (see Picture 1). In order

for univents to provide fresh air as designed, univent air diffusers and return vents must remain free of obstructions. Importantly, these units must remain activated while classrooms are occupied.

**Univent Return Vent Obstructed by Various Items**

1. To maximize air exchange, the BEHA recommends that both supply and exhaust ventilation operate *continuously* during periods of school occupancy independent of classroom thermostat control.
2. Repair and/or replace thermostats as necessary to maintain control of comfort.
3. Examine each univent for function. Survey classrooms for univent function to ascertain if an adequate air supply exists for each room. Consider consulting a heating, ventilation and air conditioning (HVAC) engineer concerning the calibration of univent fresh air control dampers school-wide.
4. Remove all blockages from univents and exhaust vents.

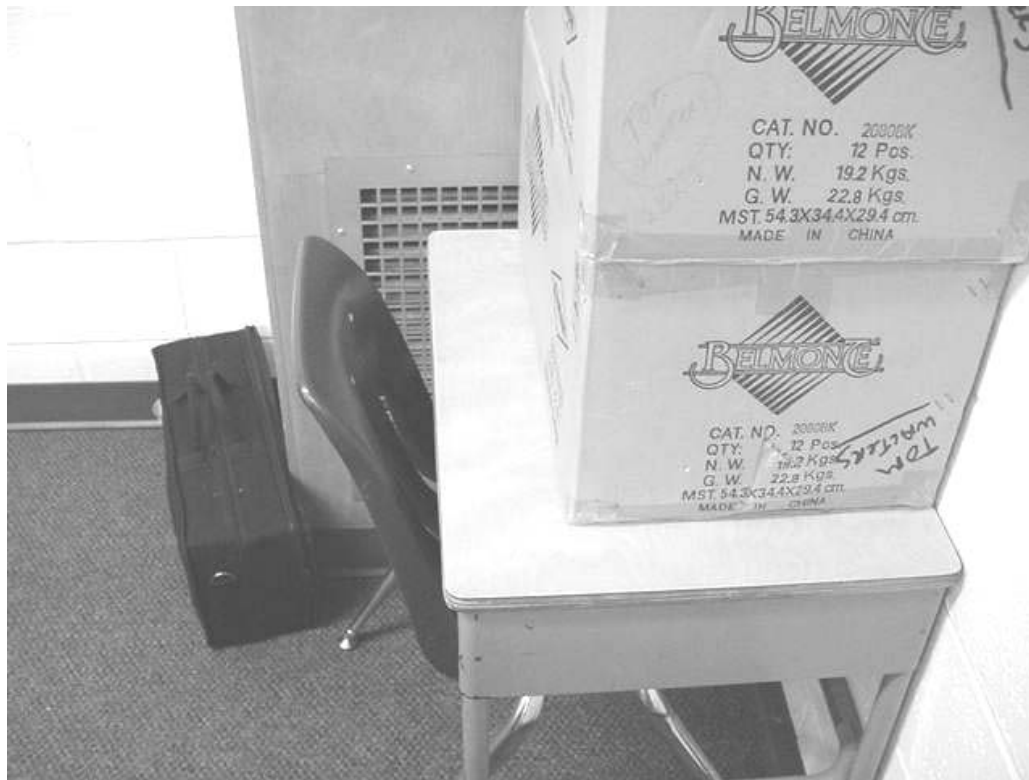
**Picture 2**

The mechanical exhaust ventilation system in classrooms consists of grated, wall-mounted exhaust vents. A number of exhaust vents were obstructed by tables, chairs, boxes and other items (see Picture 2). The location of exhaust vents can also limit exhaust efficiency when the classroom hallway door is open. When a classroom door is open, exhaust vents will tend to draw air from both the hallway and the classroom (see Picture 3). The open hallway door reduces the effectiveness of the exhaust vent to remove common environmental pollutants from classrooms. Exhaust ventilation in the music room, cafeteria and gymnasium were off or drawing weakly. The exhaust vent for the cafeteria was found occluded with accumulated dust/debris, which can decrease airflow into the vent (see Pictures 4 & 5). Without removal by the exhaust ventilation, normally occurring environmental pollutants can build up and lead to indoor air complaints.

**Items Obstructing Airflow into Classroom Exhaust Vent**

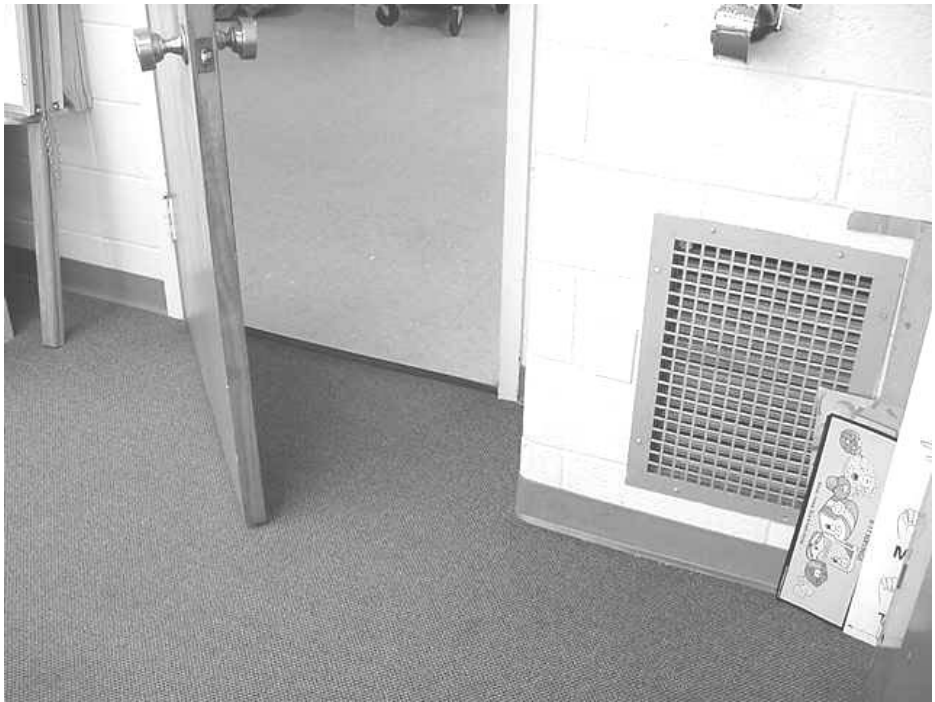
**Picture 3**

**Proximity of Classroom Exhaust Vent to Open Hallway Door**

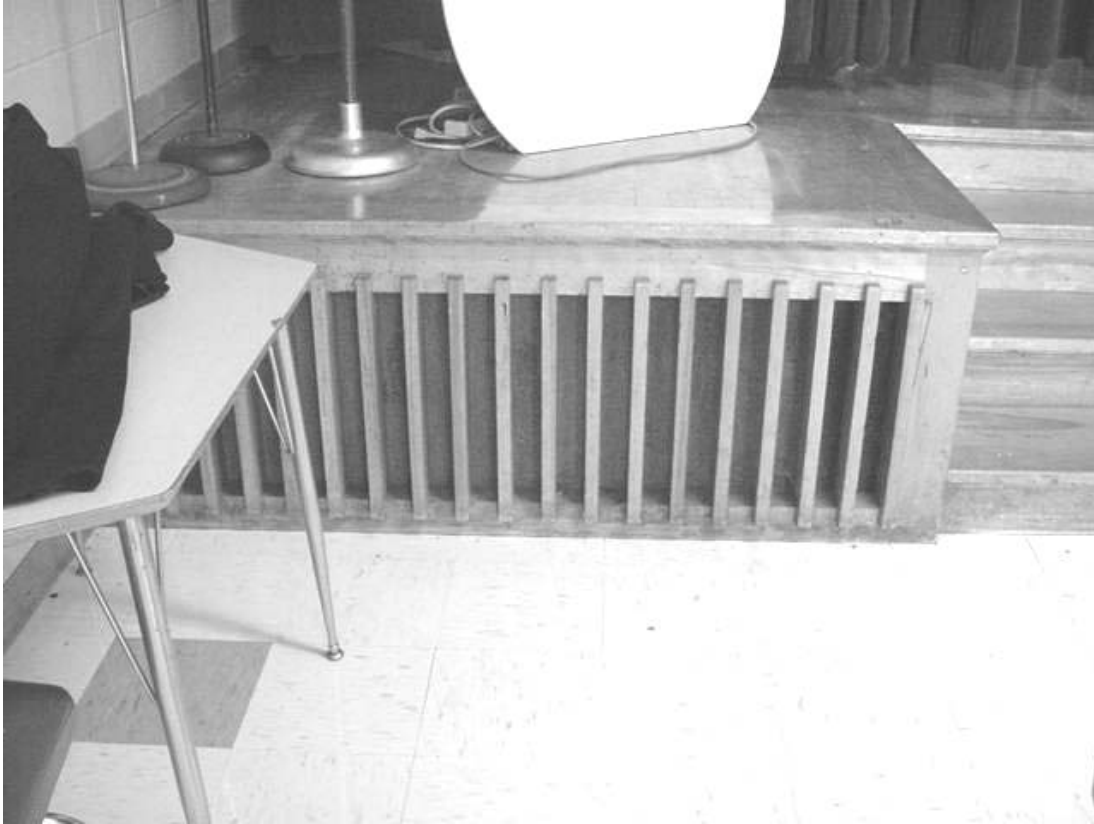
**Picture 4**

**Cafeteria Exhaust Vent under Stage**

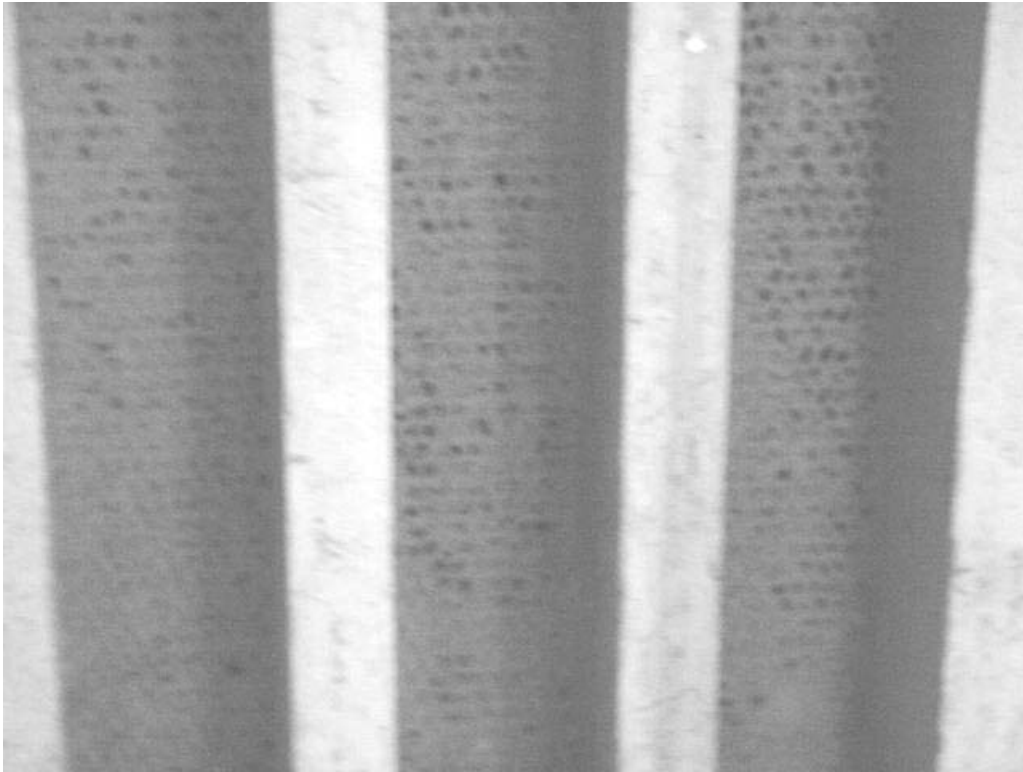
**Picture 5**

**Close-up of Cafeteria Exhaust Vent (see Previous Picture) Occluded with Dust**

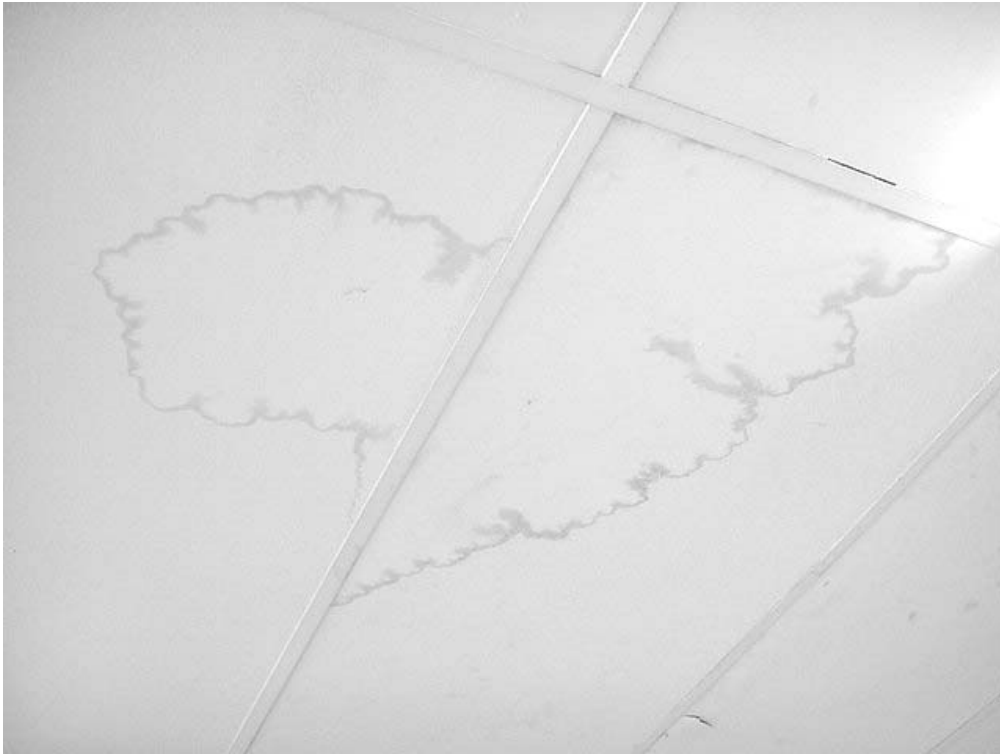
**Picture 6**

A few classrooms had water-damaged ceiling tiles which can indicate leaks from either the roof or plumbing system (see Picture 6). Water-damaged ceiling tiles can provide a source of mold and should be replaced after a water leak is discovered and repaired.

**Water Damaged Ceiling Tiles**

7. Replace any remaining water-stained ceiling tiles and building materials. Examine the area above and around these areas for mold growth. Disinfect areas of water leaks with an appropriate antimicrobial.

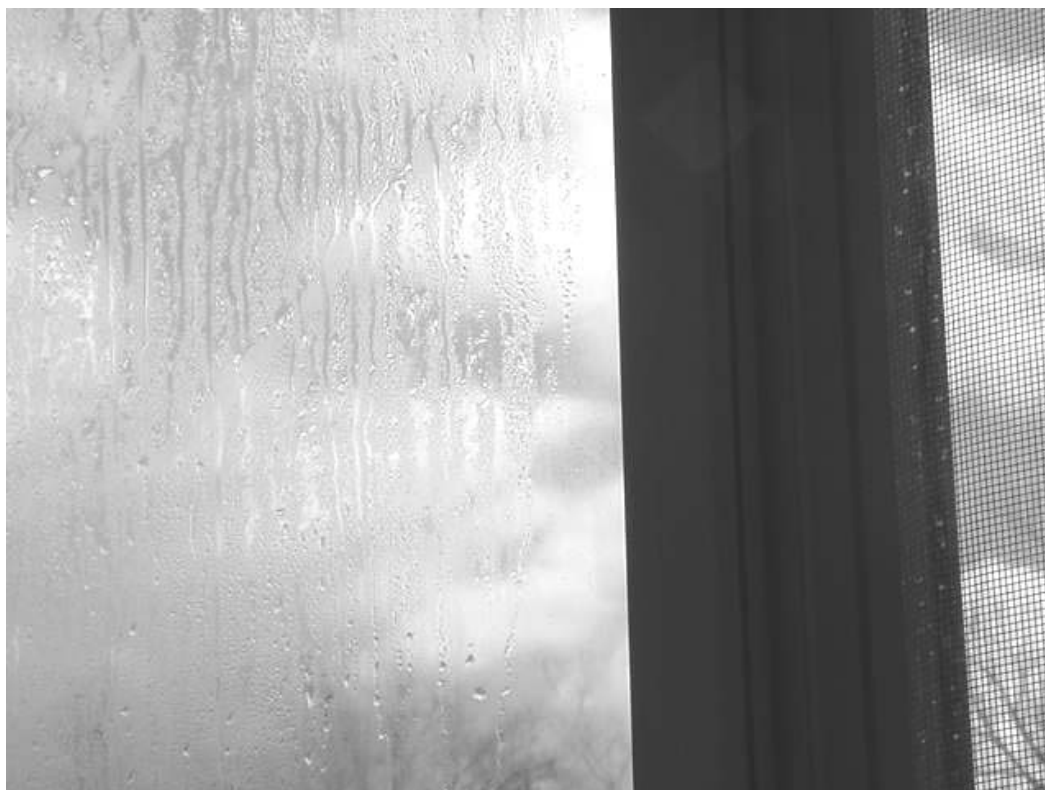
**Picture 7**

Water vapor was observed collecting within a double-paned glass window of a modular classroom (see Picture 7). This condition indicates that the window's water seal is no longer intact. Repairs of window leaks are necessary to prevent further water penetration. Repeated water damage can result in mold colonization of window frames, curtains and items stored on windowsills.

**Condensation between Window Panes in Modular Classroom**

12. Consider having windows in the modular classroom replaced or proper flashing installed to prevent further water intrusion.
13. Store cleaning products properly and out of reach of students.

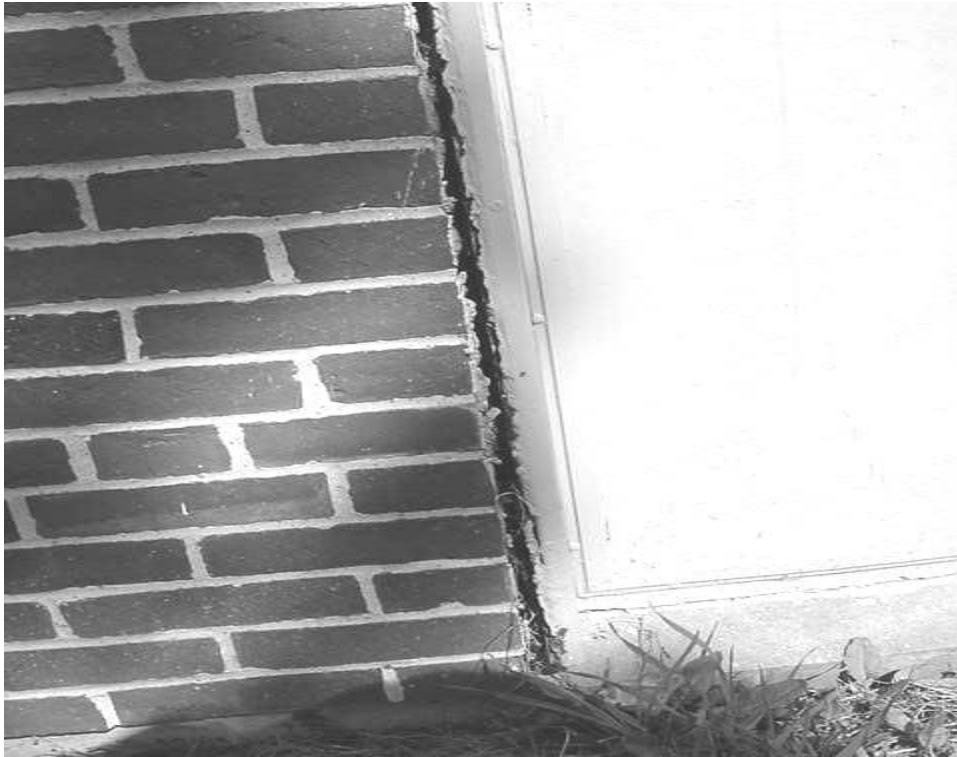
**Picture 8**

An area of possible water penetration may be along expansion joints and/or the junction of the foundation and the exterior wall system of the building. Expansion joint sealants were weathered, mechanically damaged or missing (see Pictures 8 & 9). Some of the expansion joints may allow for water to penetrate into the interior of the building.

**Space at Expansion Joint/Exterior Wall**

8. Inspect rooftop drains regularly to ensure proper drainage.
9. Seal expansion joints and around foundation to prevent moisture intrusion and subsequent water damage.

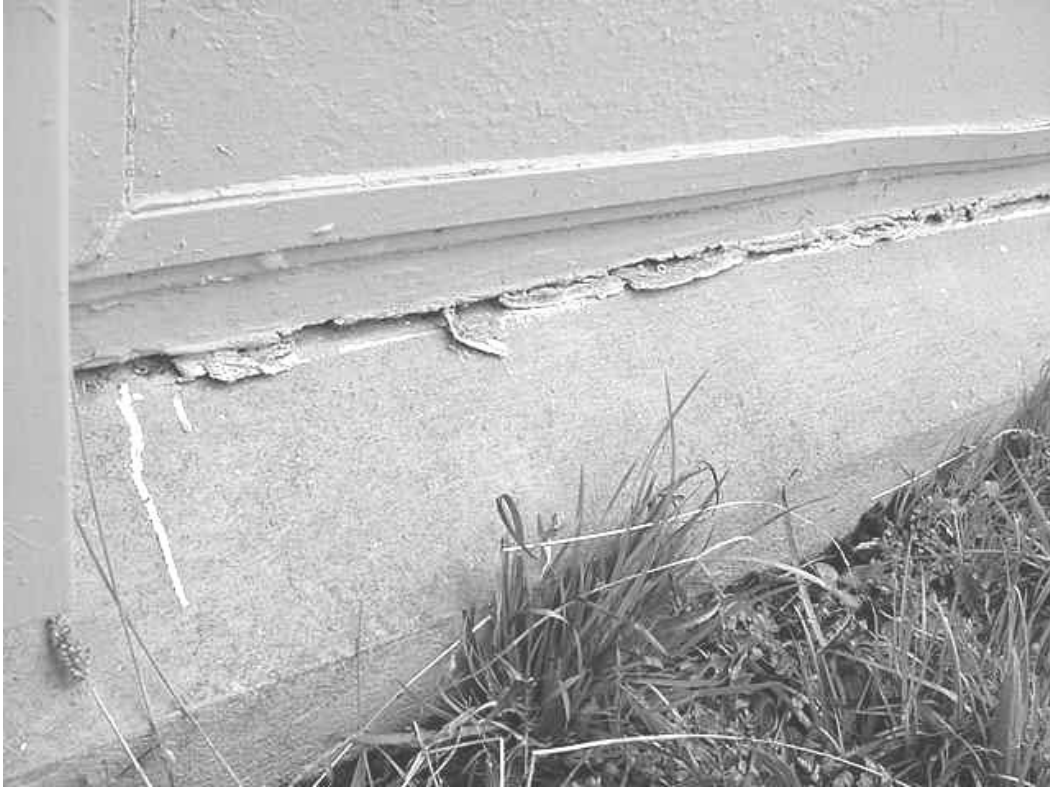
**Picture 9**

**Missing/Damaged Caulking between Foundation/Exterior Wall Panel**

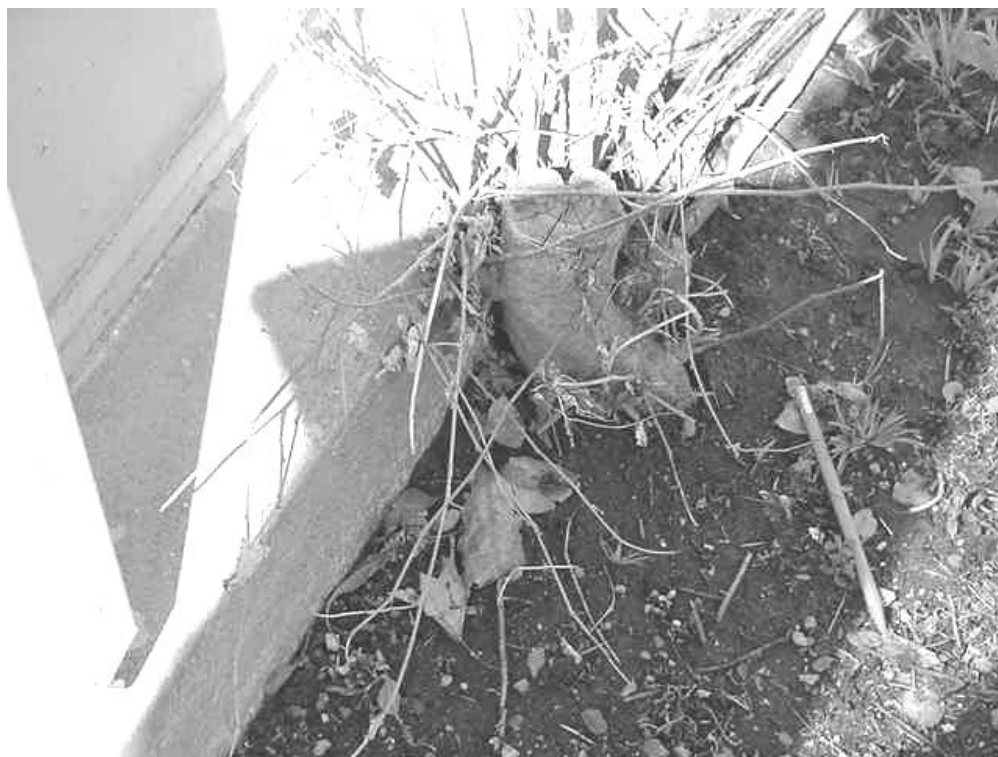
**Picture 10**

Small trees and other plants were also seen growing in the tarmac/exterior wall junction (see Picture 10). The growth of roots against the exterior of foundation walls, as well as spaces between the tarmac, can bring moisture in contact with brick and foundation structures, which may eventually lead to moisture penetration below ground level areas of the building.

**Trees/Plants Growing against the Foundation of the Building**

10. Remove plant growths against the exterior wall/foundation of the building to prevent water penetration. Trim trees in rear of building away from brickwork.

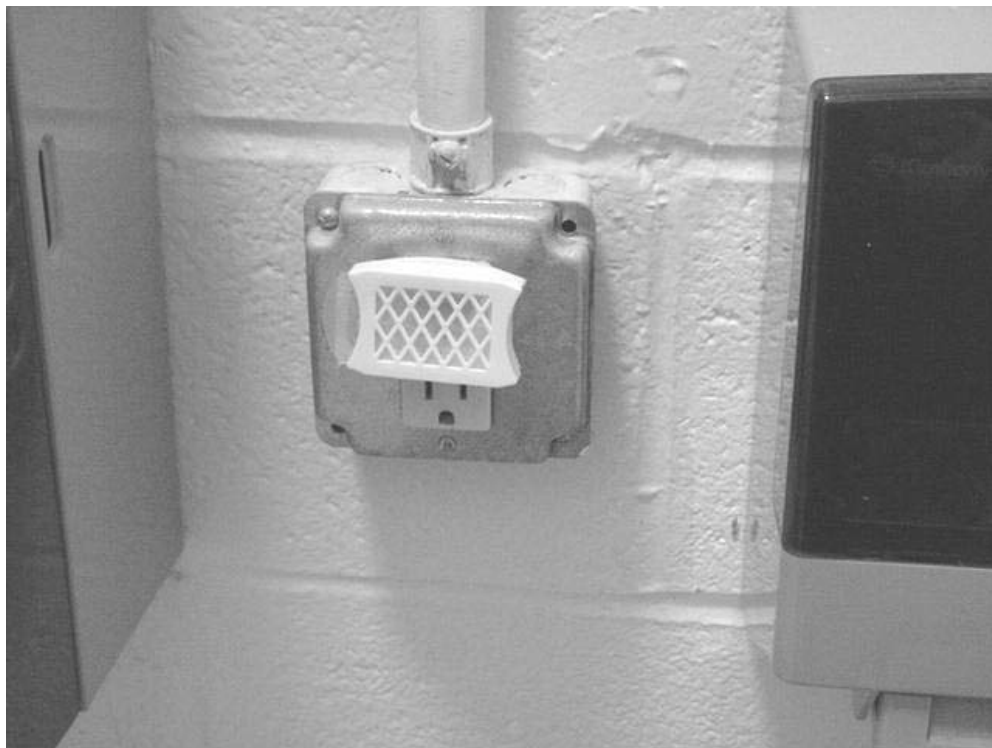
**Picture 11**

One classroom contained time-released air fresheners (see Picture 11). Air fresheners contain chemicals that can be irritating to the eyes, nose and throat of sensitive individuals. In addition, air fresheners do not remove materials causing odors, but rather mask odors, which may be present in the area.

**Plug-in Air Freshener**

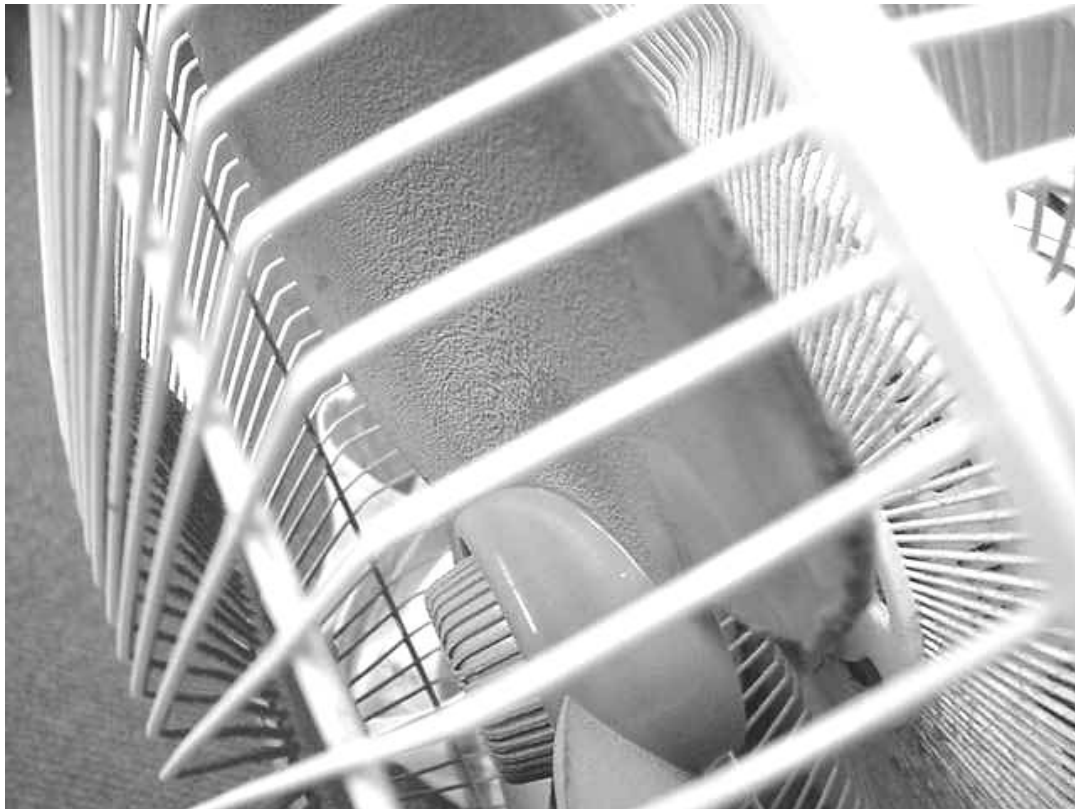
**Picture 12**

Several areas contained window-mounted air conditioners. This equipment is normally equipped with filters, which should be cleaned or changed as per the manufacturer's instructions to avoid the build up and re-aerosolization of dirt, dust and particulate matter. Accumulated dust and particulates were also noted on the blades of portable fans (see Picture 12). When fans or FCUs are activated these materials can become aerosolized.

**Accumulated Dust on Fan Blades in Classroom**

15. Clean chalkboards and trays regularly to avoid the build-up of excessive chalk dust.
16. Operate local exhaust ventilation in teacher's workroom during photocopier and lamination machine use.
17. Consider removing wasp's nests from classrooms.
18. Clean portable fan blades and exhaust vents periodically of accumulated dust.
19. Refrain from using strong scented (e.g. plug-in air fresheners) and/or VOC-containing materials.
20. Relocate or consider reducing the amount of materials stored in classrooms to allow for more thorough cleaning. Clean items regularly with a wet cloth or sponge to prevent excessive dust build-up.
21. Clean upholstered furniture on the schedule recommended in this report. If not possible/practical, remove upholstered furniture from classrooms.
